CHINA'S LARGEST LEAD-ACID BATTERY EXPORTER ILLEGALLY DUMPS WASTEWATER

Investigative Report on Leoch Battery (Jiangsu) Corp.

Lvse Jiangnan
Institute of Public & Environmental Affairs
December 2017

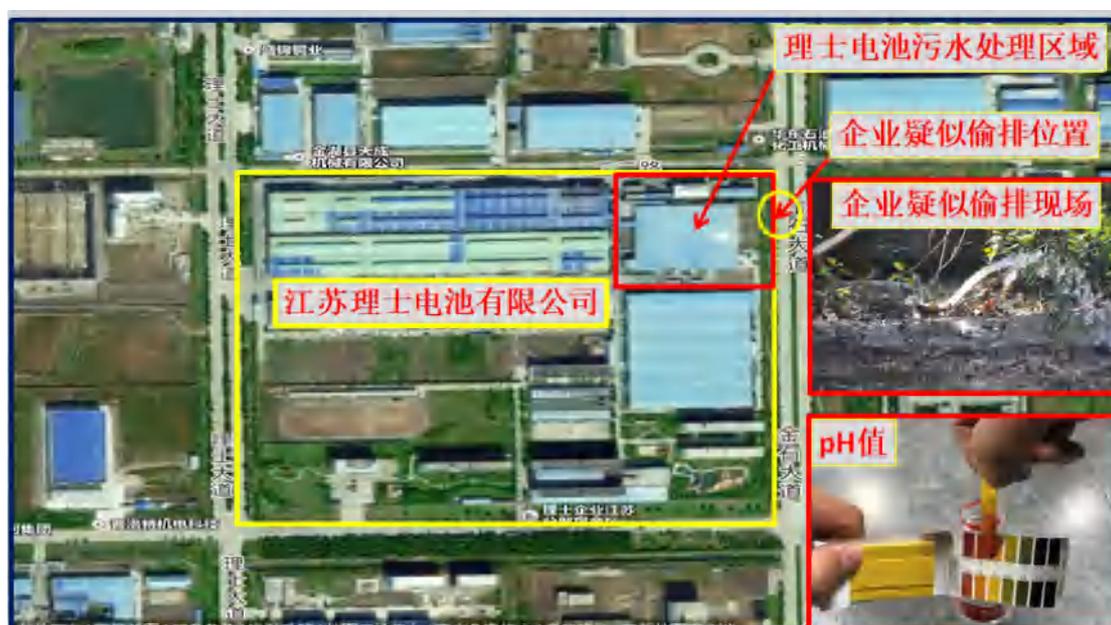
Figure 4. Suspected dumping area of Leoch Battery

Based on the findings from desktop research, Lvse Jiangnan carried out several on-site investigations. On November 20, 2017, investigators arrived at the northeast corner of the wall near the wastewater treatment area, led by local residents who had reported the company. They discovered a pipe sticking out from the factory into the outer green belt. Substantial amounts of water with unknown content flowed from the pipe onto the ground, with some water sinking into the soil (figures 4 & 5).

Since the suspected wastewater dumping area was located at Jinshi Road, which was under construction, maintenance workers told investigators that they found the pipe dumping sewage into green belt multiple times, but have no clue what was in the sewage or what harmful impacts it may pose.

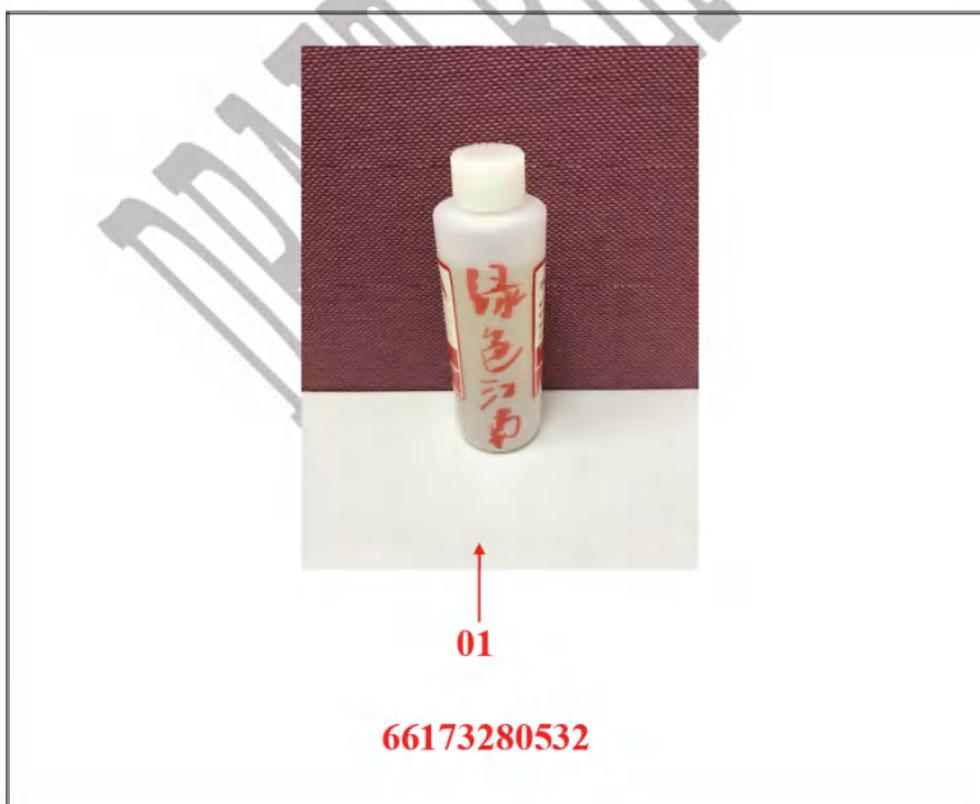
Figure 7.1. Water sample sent to BV by Lvse Jiangnan

Lvse Jiangnan collected a sample of wastewater suspected to have been dumped and commissioned a qualified third-party testing lab – Bureau Veritas Consumer Products Services (BV) – to examine and analyze the sample.

Test results by BV show that the pH level of the water alleged to have been dumped by Leoch Battery is 2.23 (highly acidic), while lead content of the water measured 8159 µg/L (figures 7.1 & 7.2).

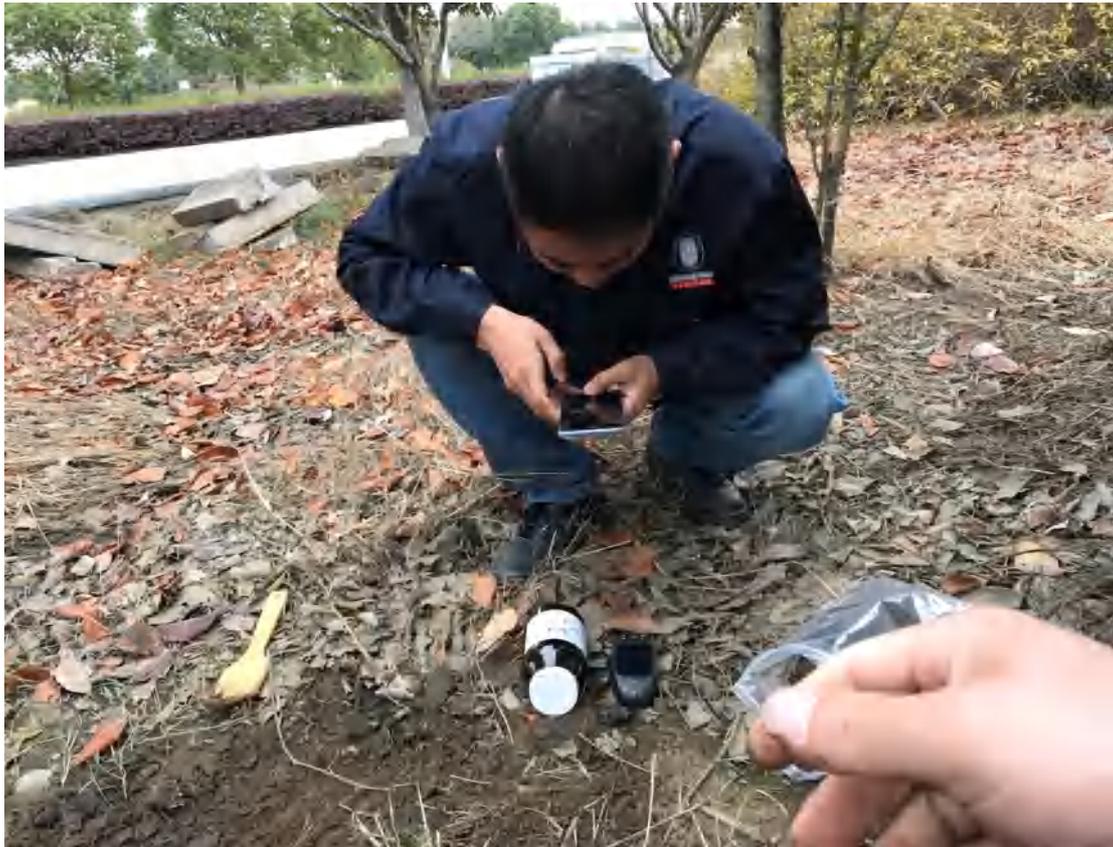
Figure 9. BV staff locating sampling site

On November 30, 2017, Lvse Jiangnan commissioned Bureau Veritas staff to collect soil sample 1 from the location where the highly acidic wastewater containing lead was alleged to have been dumped (figure 9).

Soil sample No.1: pH=3.66 (highly acidic); lead concentration= 4610 mg/kg

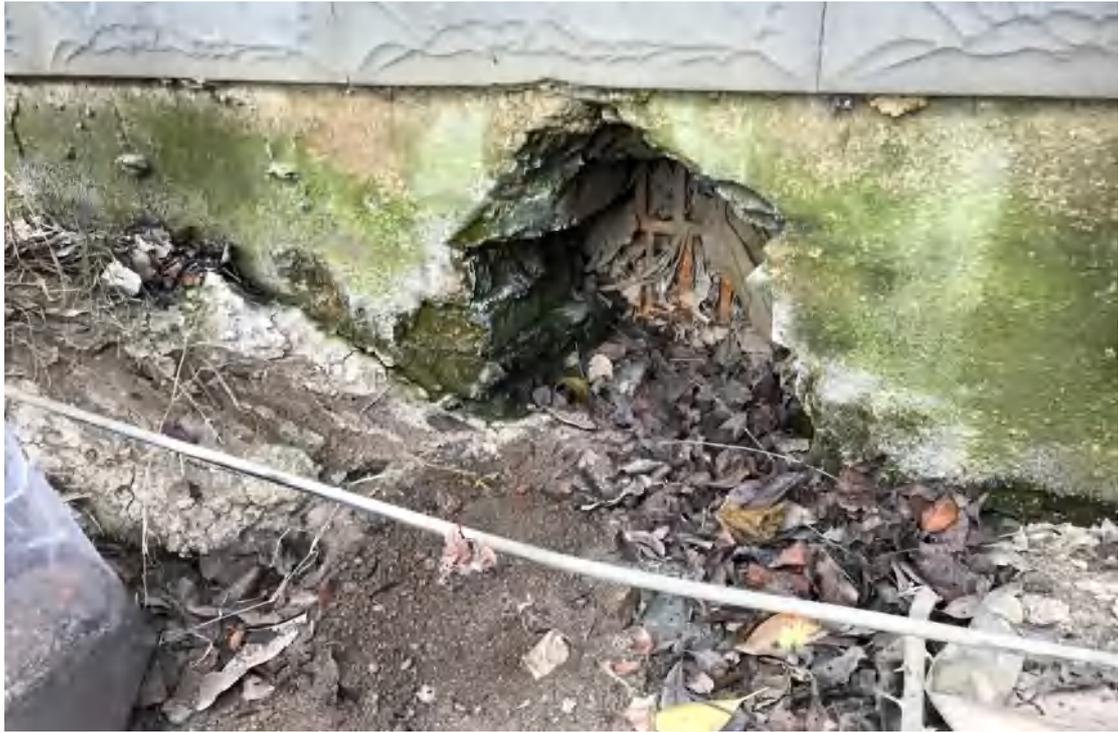
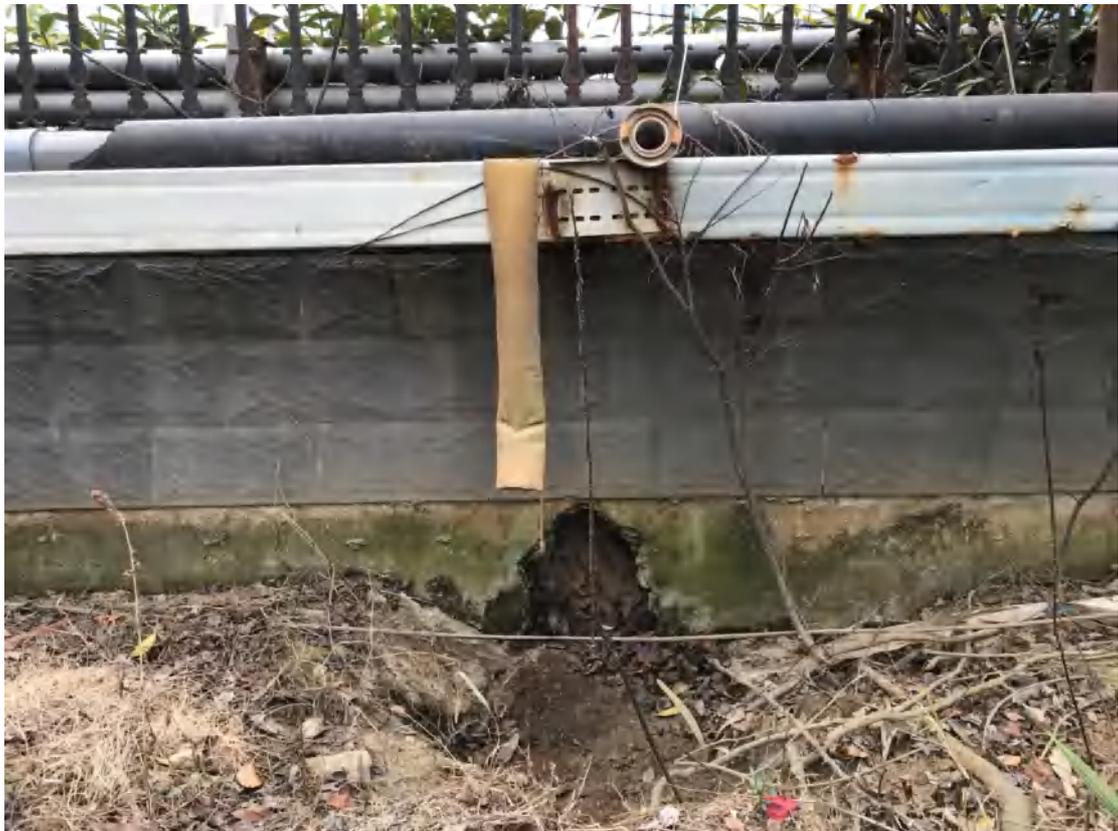
Then Lvse Jiangnan investigator found a concealed hole under the wall a few meters away. Although no water was being discharged through the hole at that time, the soil around the hole had been eroded into a muddy pit. The muddy side of the pit had been washed away to reveal sand. Investigators commissioned BV staff to collect sand sample No. 2 near the pit (see figures 10.1, 10.2, and 11).

Figure 10.1. The hole in the wall

Figure 10.2. The hole in the wall

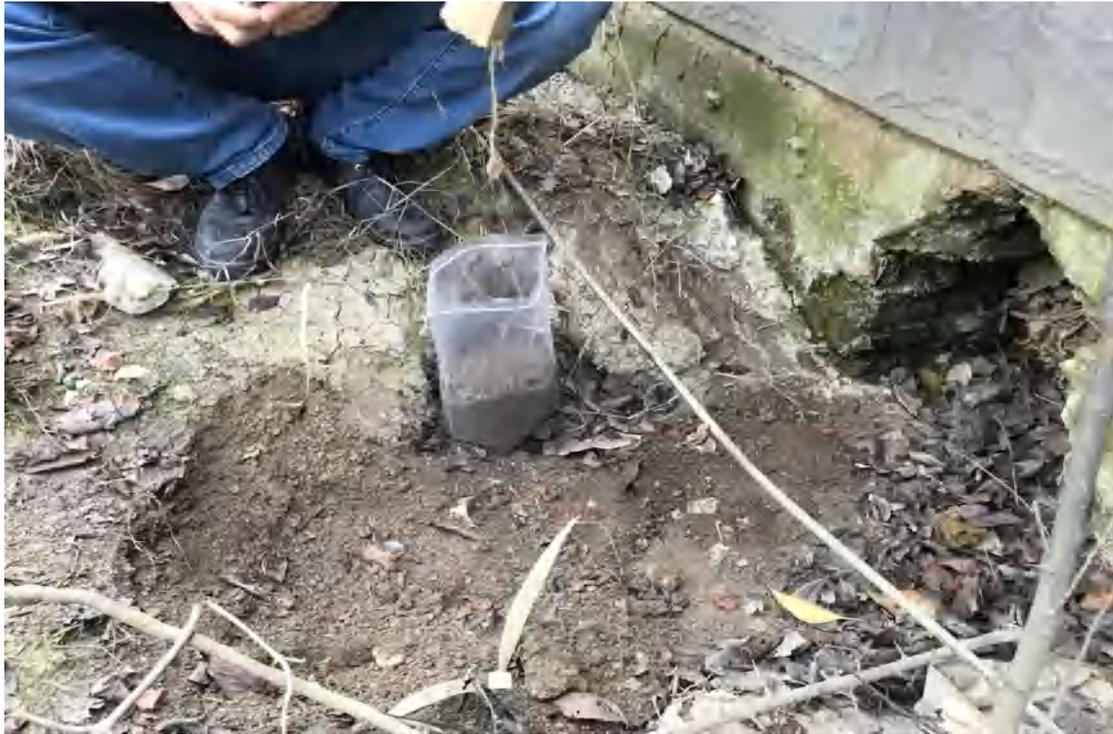
Figure 11. BV staff locating sampling site

Sand sample No. 2: pH=3.91 (highly acidic); lead concentration= 1990 mg/kg
